**LOCKE WATERVILLE CORPORATION DAM
NH 00416**

**PHASE I INSPECTION REPORT
NATIONAL DAM INSPECTION PROGRAM**

OCTOBER 1978

Name of Dam: LockeWaterville Corp. Dam, I.D. NH 00416
State Located: New Hampshire
County Located: Grafton
Stream: Tributary to Chickenboro Brook
Date of Inspection: June 5, 6 and 7, 1978

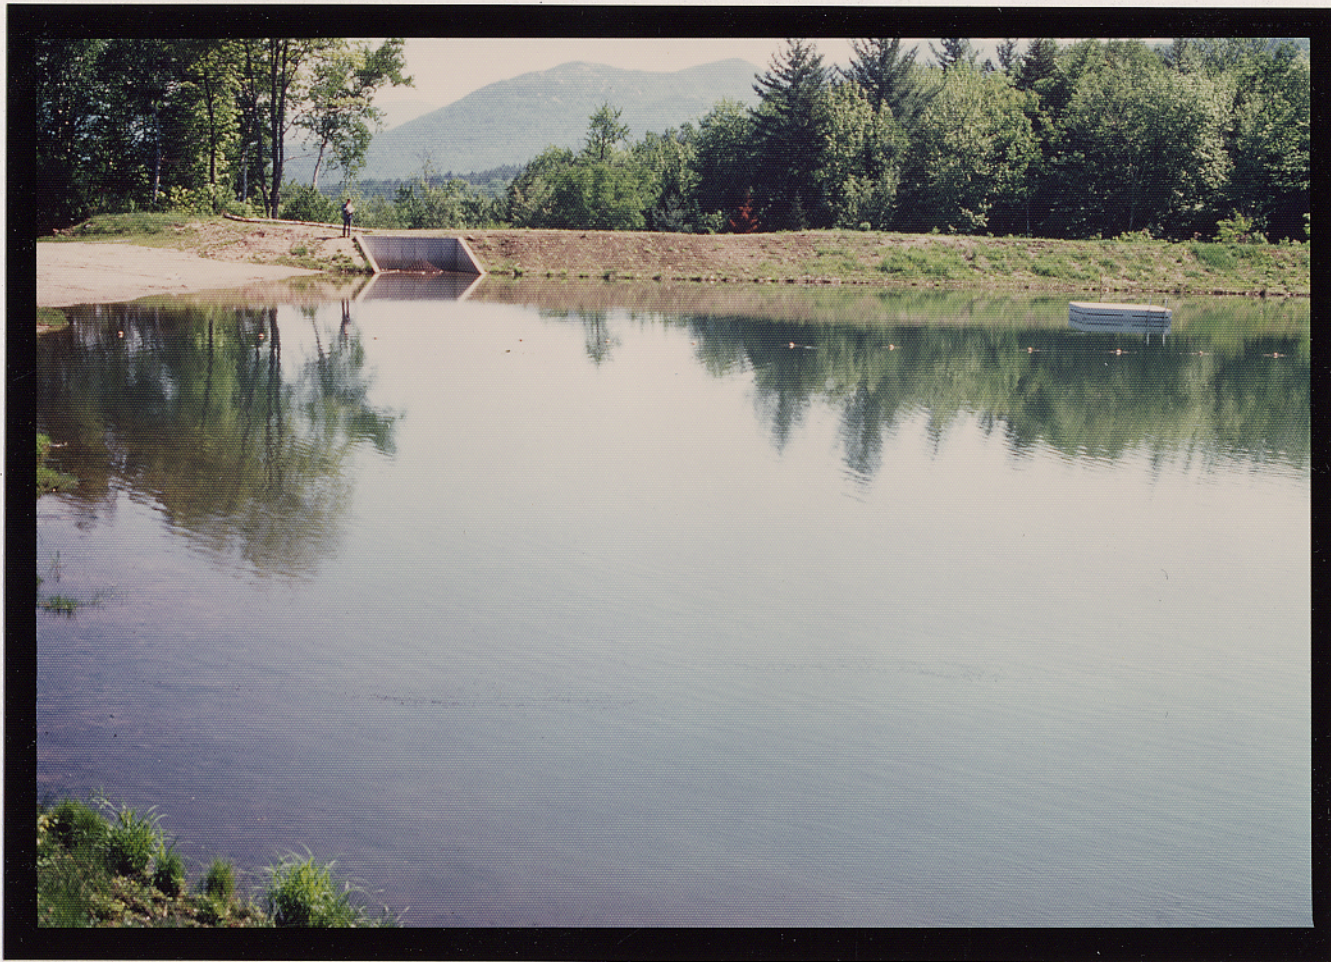
LOCKE WATERVILLE DAM

View of the dam from the upstream side. Note that the rebuilt section of the dam at the left abutment is lower than the remainder of the dam. The auxiliary spillway entrance is to the left of the dam.

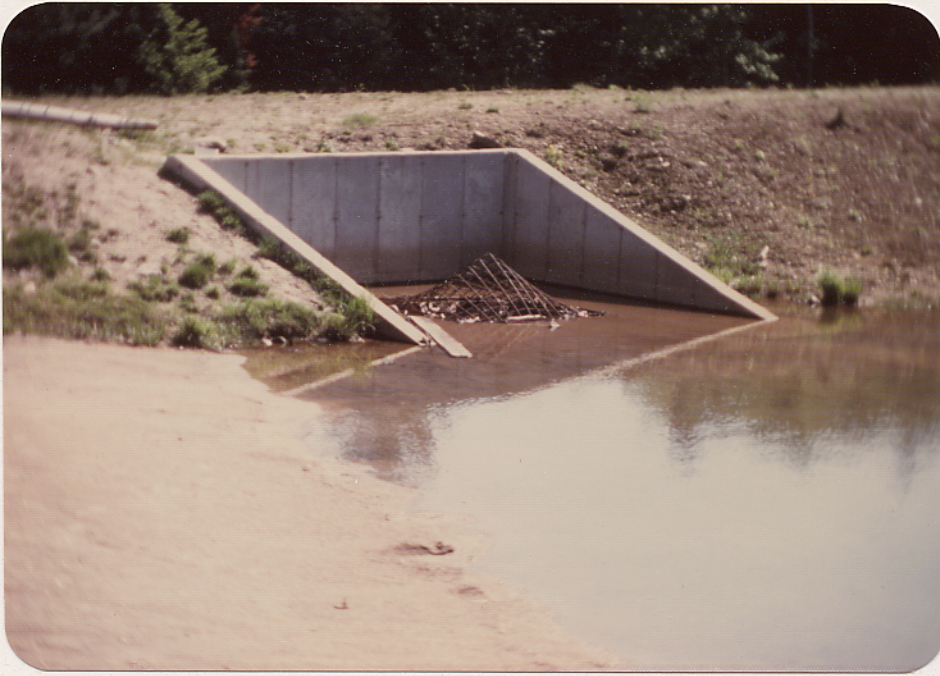
Photo 1 - View of the service spillway on upstream face of dam.

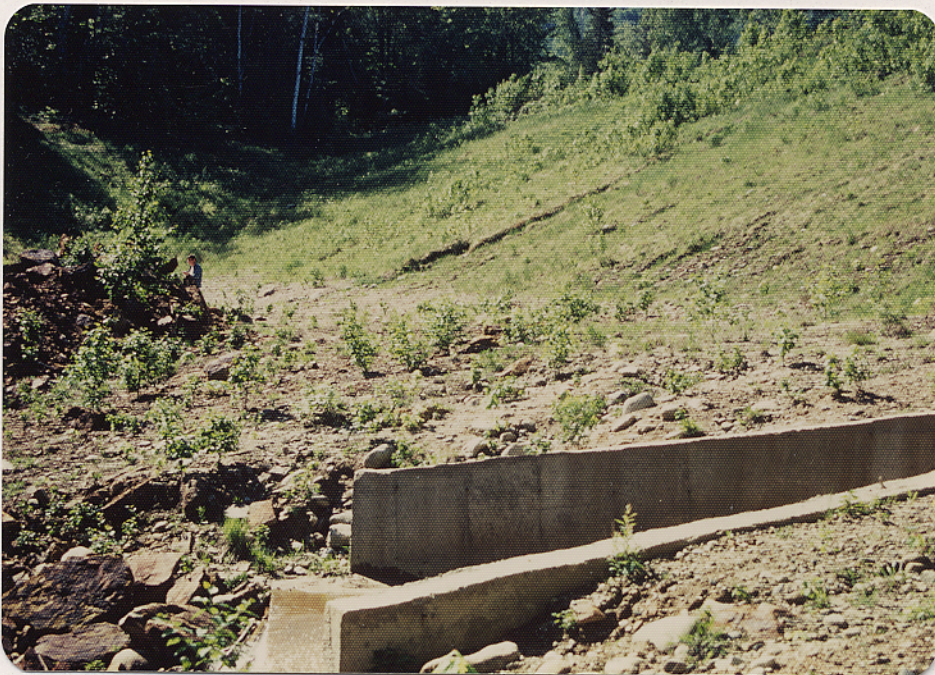
Photo 2 - View of the downstream face of dam looking toward the right abutment from the berm level. The service spillway outlet is in the foreground.

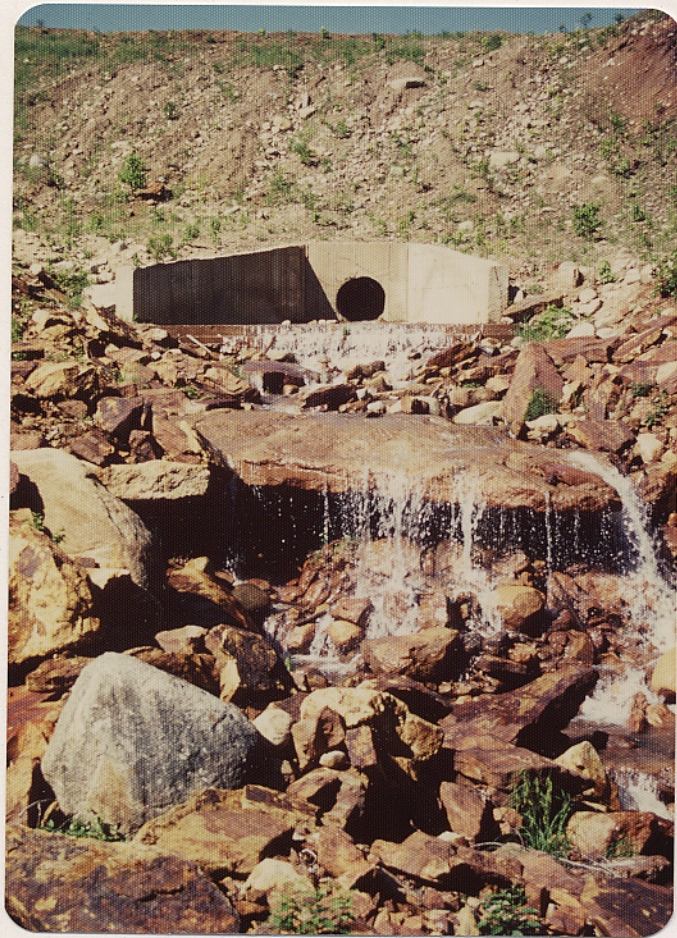
The overall physical condition of Locke Waterville Corporation Dam is fair. The stability of the earth embankment is in question, since its crest is at an irregular elevation indicating that settlement may have taken place. In addition, the left and right downstream abutment contacts are poorly graded with the right abutment especially in need of correction because of erosion and wet spots caused by surface runoff. The downstream slope at the rebuilt section is eroded because of a lack of binding vegetative cover.

Photo 3 - View of the downstream face of the dam showing the service spillway outlet and the rebuilt section of the embankment. Note the absence of vegetation on embankment slope where rebuilding was done.

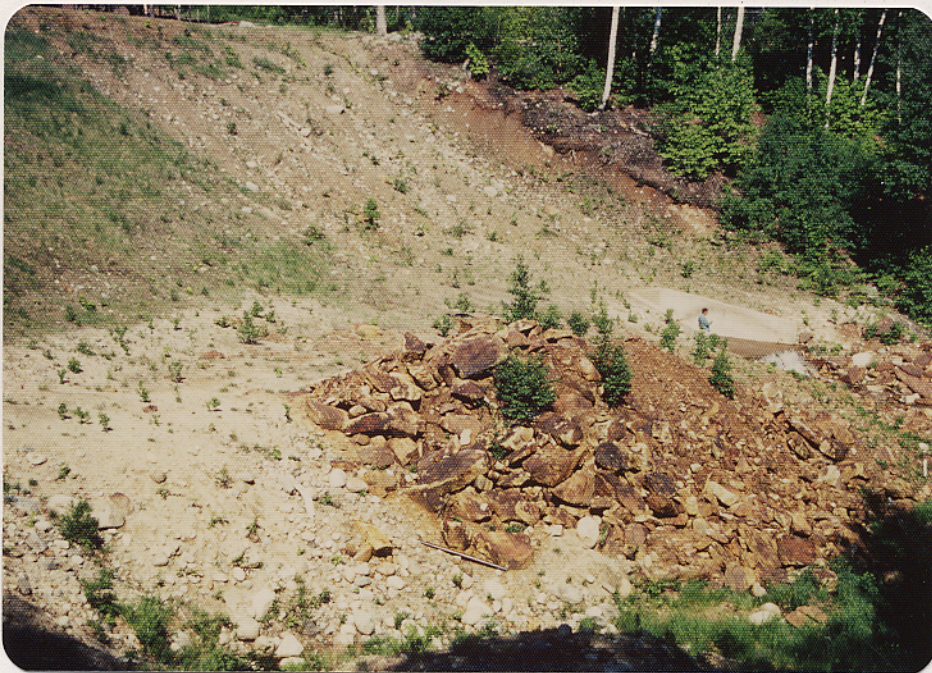
Photo 4 - View of the downstream embankment slope looking toward the left abutment. Note ungraded stone protection piles at berm level.

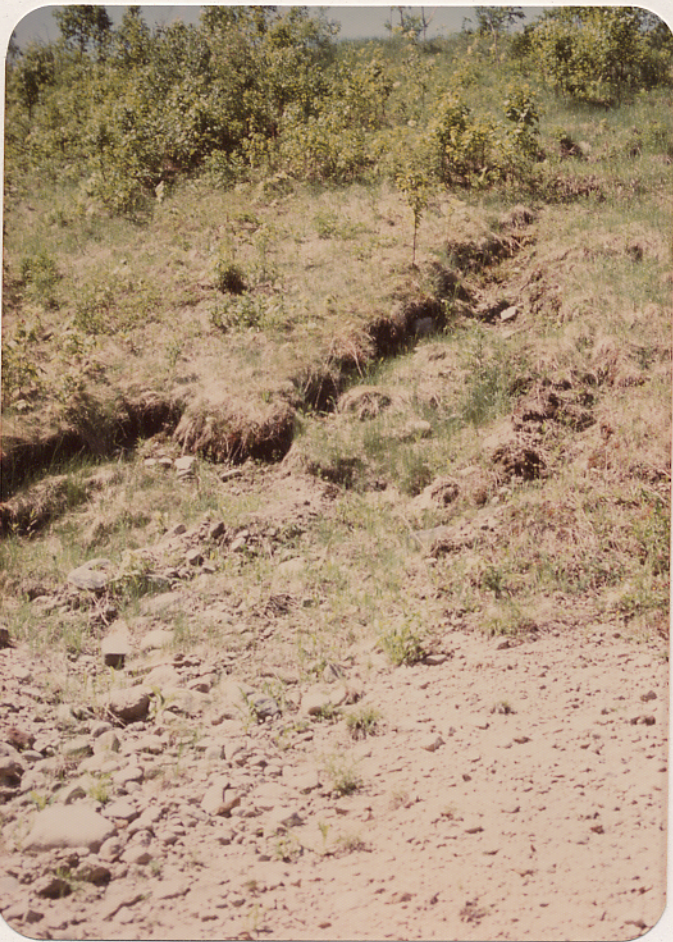
The upper part of the slope contains two wet spots where the phreatic surface has apparently penetrated to the face. The lower part of the rebuilt downstream slope is poorly trimmed to grade, and unprotected leading to erosion due to surface runoff. There is a source of leakage at the downstream toe of the embankment at or near the right abutment contact seeping at a rate of 3 gpm whose origin is believed to be the reservoir.

Photo 5 - View of downstream embankment slope showing local erosion.

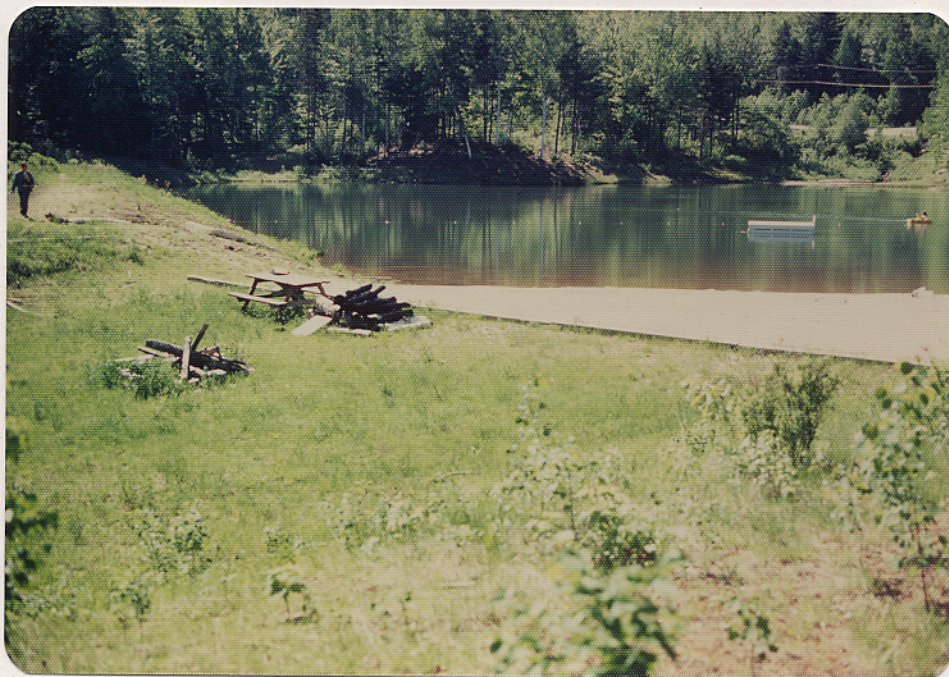
Photo 6 - View of dam and impoundment from the auxiliary spillway area on the left abutment.
